Bifenthrin pesticide contamination: impacts and recovery at Jamison Creek, Wentworth Falls.

Abstract

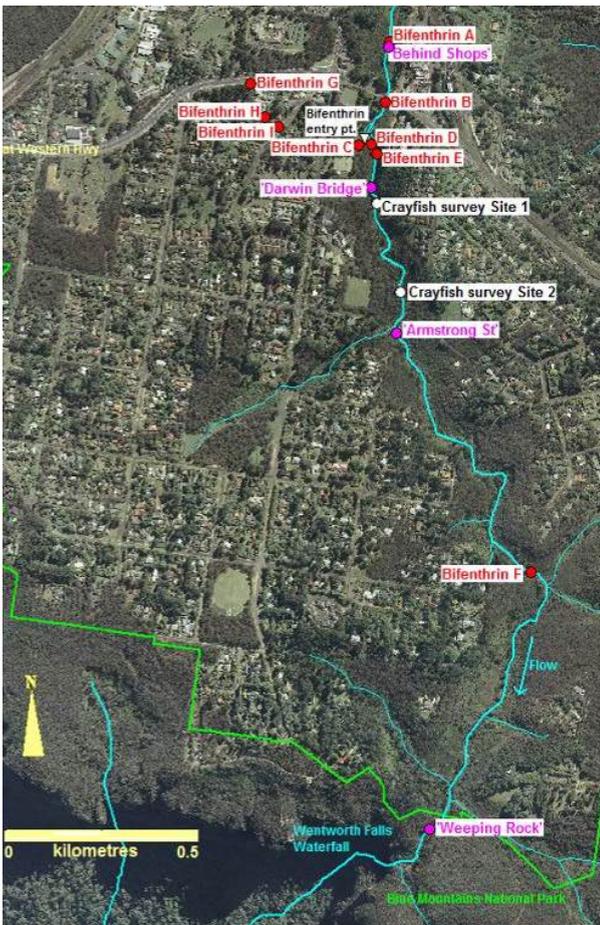
Figure 1 (left). Map of Jamison Creek showing sampling locations. Figure 2 (right). BMCC & DPI staff inspect dead crayfish at Jamison Creek.

Prior to Bifenthrin contamination, Jamison Creek was sampled on eight occasions between March 2005 and March 2012 (at Armstrong St from 2005-07 and at Weeping Rock from 2008-12). Weeping Rock (2200m downstream of Bifenthrin entry point) continued to be sampled following the incident, along with two new sites: ‘Behind Shops’ (290m upstream of Bifenthrin entry point) and ‘Darwin Bridge’ (120m downstream of Bifenthrin entry point). These three sites were sampled at approximately monthly intervals in the period from July to November 2012, then at three other times (9 months, 12 months and 20 months) post-contamination. See figure 1 for an illustration of site locations.

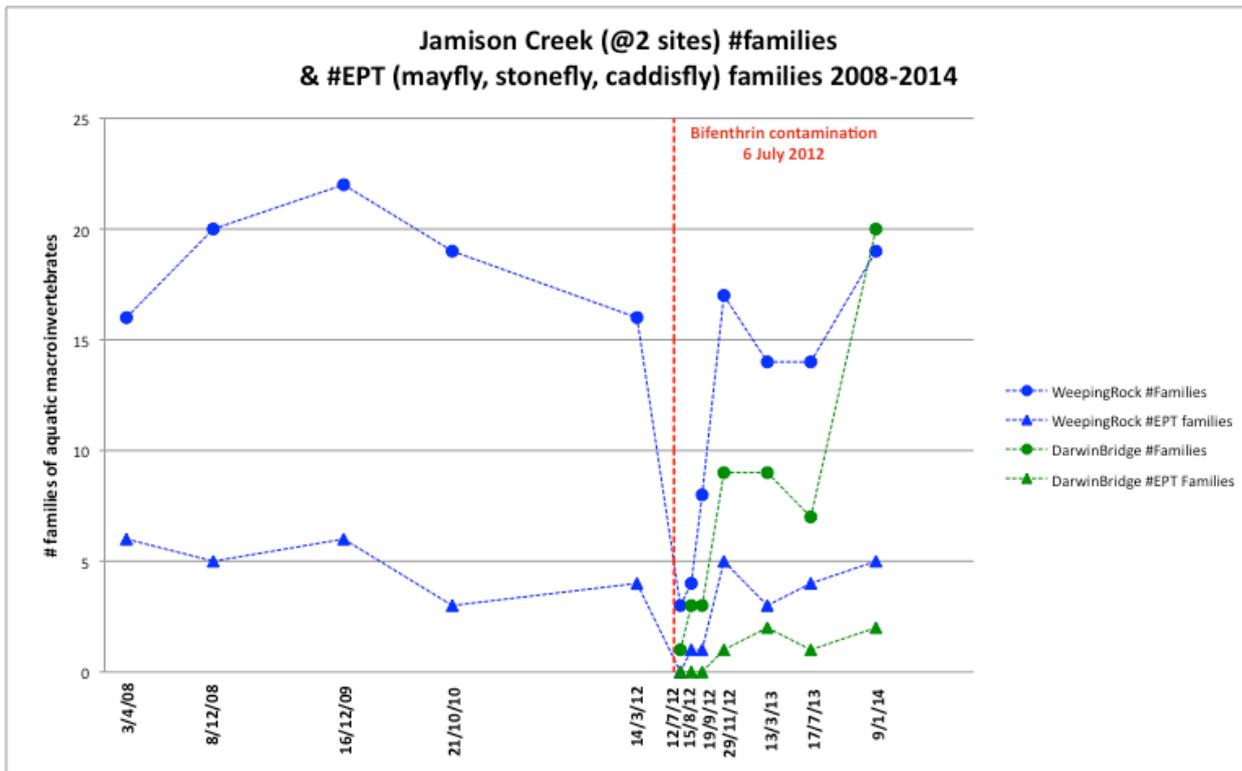
Figure 3. Biplot showing the number of families of aquatic macroinvertebrates and the number of EPT families recorded at the Weeping Rock and Darwin Bridge sites over time.

A total of 2330 macroinvertebrates were collected from 29 samples at four sampling sites in Jamison Creek, from March 2005 to January 2014. Macroinvertebrate communities were significantly, adversely affected by the Bifenthrin contamination. Summary macroinvertebrate statistics (Table 2) show that abundance of invertebrates changed significantly in Jamison Creek ($F=7.03$, $p=0.004$) after contamination, dropping from a mean of 100.6 to 13 animals per sample for the three month period following the incident. Eighteen months post-contamination, abundance has returned to near pre-incident levels (mean 92.9 animals per sample). Taxonomic richness changed similarly ($F=7.03$, $p<0.0001$), dropping from a mean of 14.7 families per sample to 3.7 families per sample following the contamination. Again the taxonomic richness of Jamison Creek has returned to near pre-incident levels (mean 13.6 families per sample). The SIGNAL-SF biotic index was also significantly lower (mean 5.9) following the incident ($F=4.5$, $p=0.021$), compared to other samples from Jamison Creek (mean 6.5). SIGNAL-SF scores have since returned to levels (mean 6.3) comparable to pre-contamination results. Figure 3 graphs the number of families and the number of EPT families recorded at the two downstream sites over time.

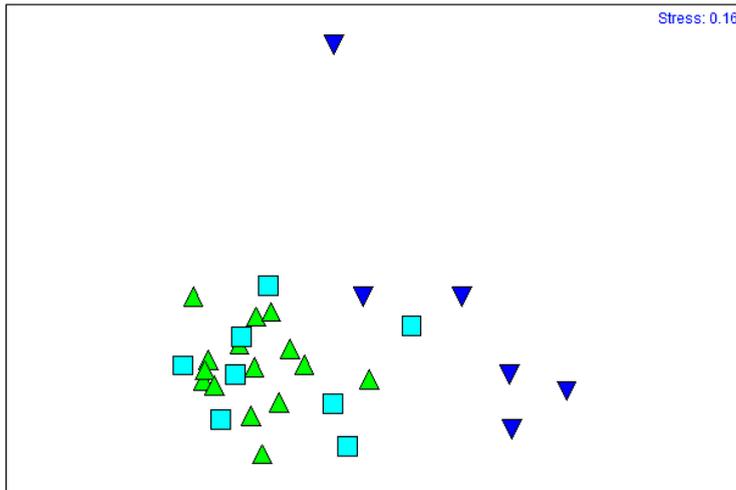
Figure 4 (left). NMDS ordination of Jamison Creek macroinvertebrate data 2005-2014. Stress = 0.16. Each symbol represents a macroinvertebrate sample. ‘Reference’ samples (upstream of or prior to contamination) are upward green triangles, ‘impact’ samples (downstream of contamination in July, August and September 2012) are downward dark blue triangles and ‘recovery’ samples (downstream of contamination in November 2012 to January 2014) are light blue squares.

Samples collected downstream of the contamination during July, August and September 2012 had a modified macroinvertebrate community structure, compared to all other Jamison Creek samples. The nMDS plot (Figure 4) shows that the 6 macroinvertebrate samples collected downstream during this period are positioned well separated from the cluster of all other Jamison Creek samples. The relative distance of these samples away from the other clump of samples represents ecological distance due to a loss of macroinvertebrate groups normally found in Jamison Creek. ANOSIM

results (Table 3) confirm that these 6 samples are statistically distinct from the others, with an R statistic of 0.834 (and very high significance). The most recent samples downstream from the Bifenthrin entry point have revealed a community structure very similar to that recorded prior to the contamination (with an R statistic of 0.162, not significant).
